EXTERIOR INSULATION & FINISH SYSTEMS

PRELIMINARY INFORMATION

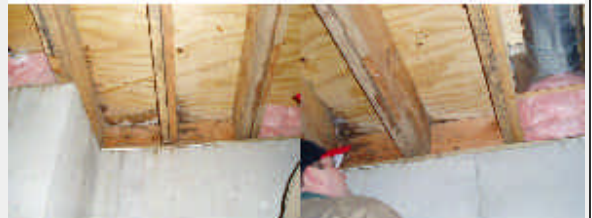
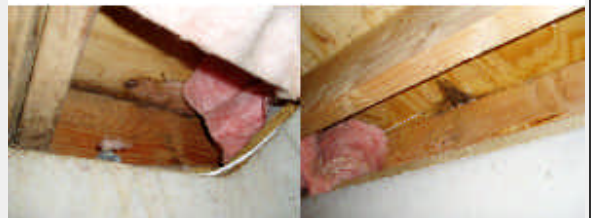
Photo1,2,3=W3, Photo 4 Atrium Door.

Yes. Below window W3, Rear Door Atrium 3, and currently repairs underway under window W1. Water staining of the subfloor & wood framing noted. White growth noted in both locations.

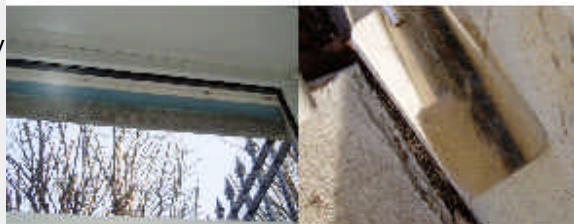
The thickness of the resinous base coat was noted, and it appears to be 1/8" or a little less in the observed location. At least half of the bottom termination edge is not correctly basecoated to the back edge. And very little has finish coat to the bottom back edge.

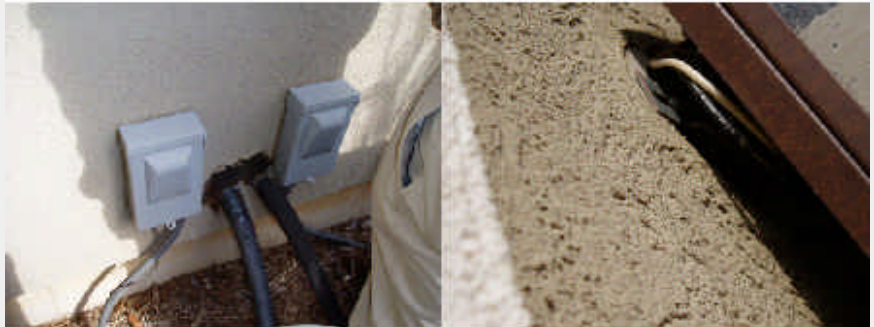
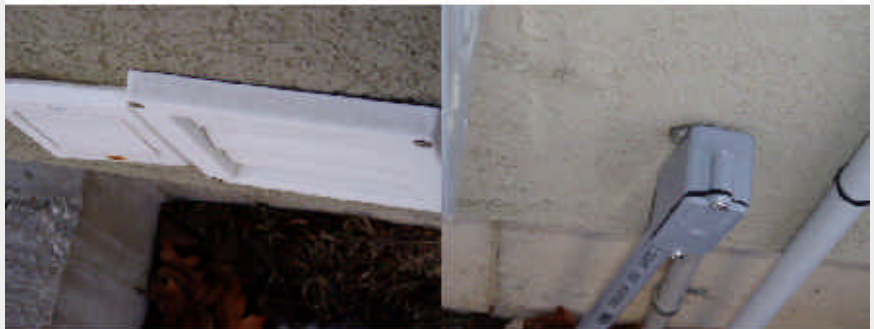
The EIFS materials are covered with the concrete back step to the atrium door. This condition is not acceptable.

Action Necessary - After an inspection of the exposed terminations, backwrapping was not evident in some locations. This condition is not acceptable considering industry standards. All penetrations are to be backwrapped during installation with a base coat, and then a backer rod installed in the gap between the penetrating material and the installed EIFS material, including light fixtures and electrical conduit, air conditioning penetration and dryer vent. Lower termination is to be installed according to EIMA Guidelines.

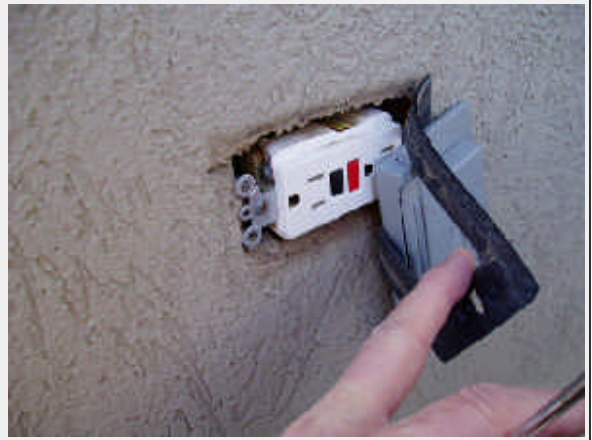
Action Necessary - Electric outlet on rear of house is not correctly sealed and backwrapped.

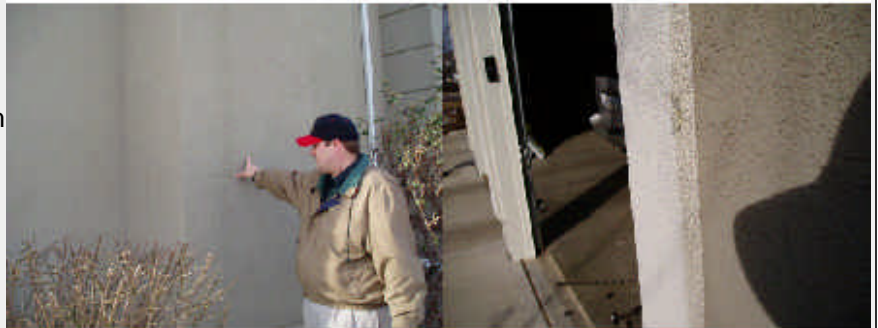
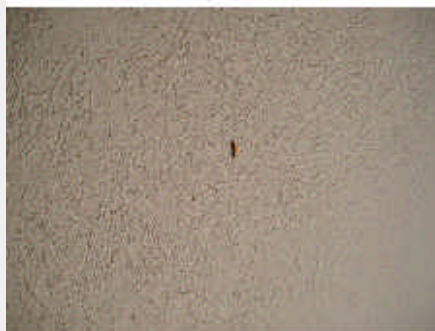
Fireplace, GD#3, Right of Garage Entry

Action Necessary - There is physical damage to the siding material. Repairs are needed to prevent moisture intrusion. Damage in wall to right of side garage door. Also damage to trim right of GD#3 and freeze damage to the fireplace stack .

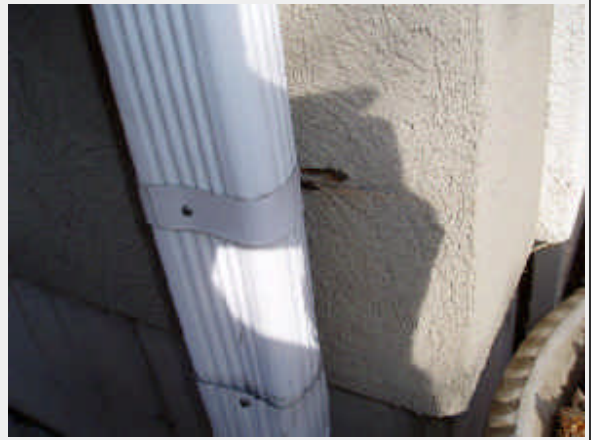
Attention Needed- The downspouts' securing straps appear to be nailed through the siding. Industry standards call for a plastic sleeve to be inserted through the siding and then a screw be installed through the sleeve. Repairs are needed. EIMA Guidelines 1996 Version, page 22.

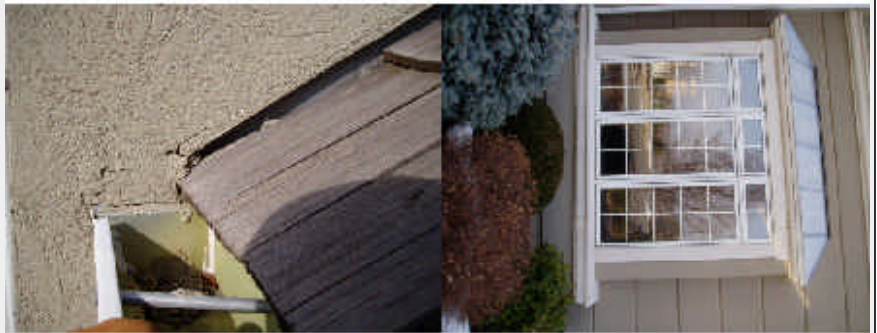
KO # 7 Copper roof over W#2.

Action Necessary - There is no kick-out installed at the lower edge where the lower roof edge terminates at the siding. This condition will allow water to enter the wall cavity. This condition is not acceptable. The National Association of Home Builders has determined the lack of kick-outs to be the second leading cause of moisture intrusion in walls, second only to window misinstallations. EIMA Guidelines, 1996 Version, page 27. Only kickout location #KO-6,

on the South wall, appears to have been an attempt to make a kickout.

Also noted is the copper roof extension over windows W#1 & W#2, both of the se copper extensions are in contact with the EIFS finish material on both shoulders and do not extend outward over the front edge far enough for the water to run off and fall to the ground. As installed both of these extensions contribute to the moisture conditions noted.

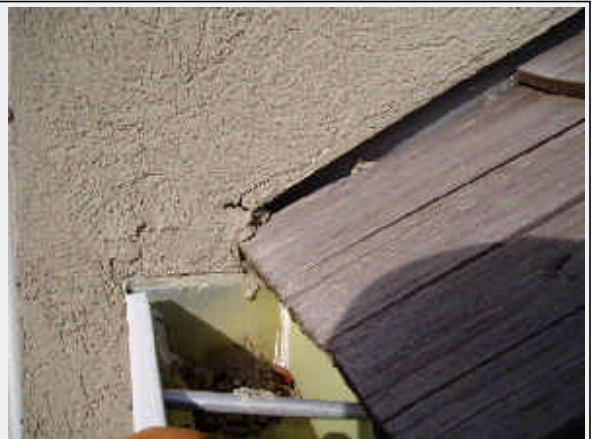
Adequate clearance between roof covering and adjacent wall covering.

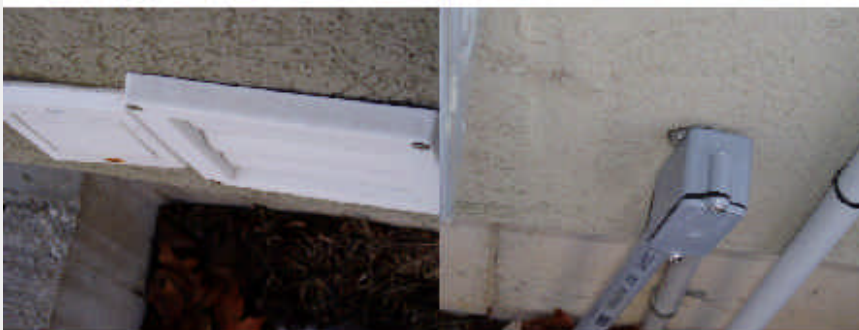
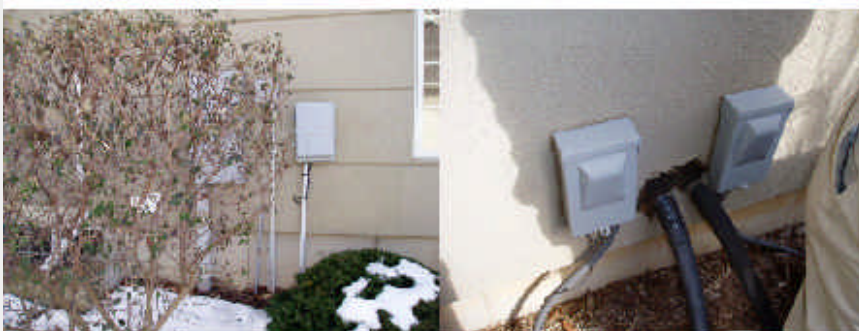
Dryer, Misc Elect, Tele,Cable, A.C.

Air Conditioning Line Set. Air Conditioning Service Disconnect. Doorbell. Rain Gutter Downspout Attachments. Clothes Dryer Vent. Electrical Outlets. Miscellaneous Electrical Fixtures. Gas Line Pipe. Hose Bibs. Intercom orr stereo speakers, Lighting Fixtures. Telephone Service Entry. EIMA Guidelines 1996 version pages 21, 23,24, 25.

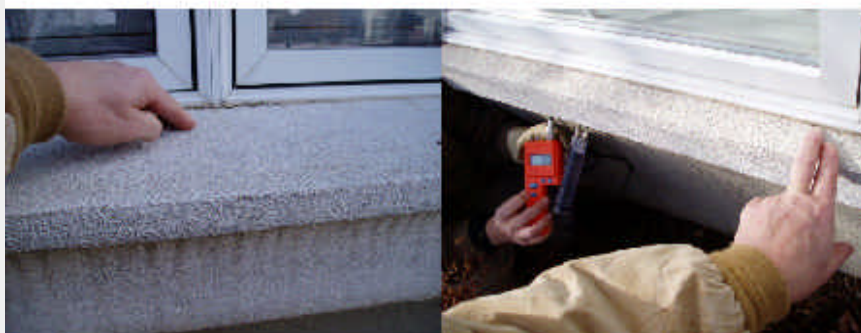
The installed head flashing appears to be installed correctly on half of the windows and several windows show no flashing W#18 & W#19. There may be others that will need to be addressed when making the recommended modifications. Action Necessary - The window vertical terminations and under sides of the sills do not appear to be correctly installed. The correct installation should be the insulation board with basecoated backwrapping and a 3/8" gap allowing for a backer rod to be installed with a manufacturer approved sealant covering the backer rod and edges between the siding and window header, brick mould, or window sill. All installed windows are similar. The appropriate detail is noted in EIMA Guidelines 1996 version, page 6 & 7 & 8.

Sills on several windows have come loose which allows water entry. This condition will not be present after correct sealant and backer rods are installed.

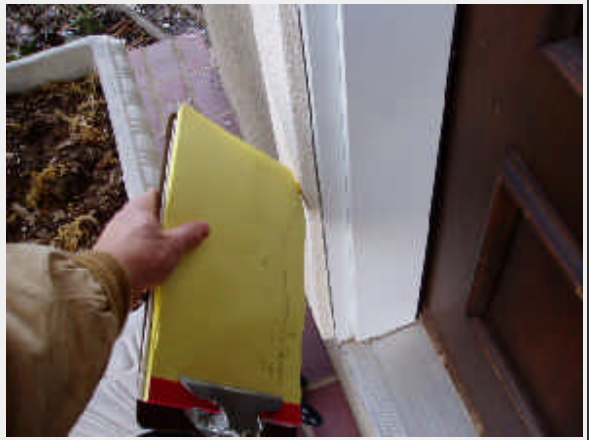
There are several open gaps among vertical terminations at doors that can allow water entry. These will be eliminated when proper backerrod and sealants are installed.

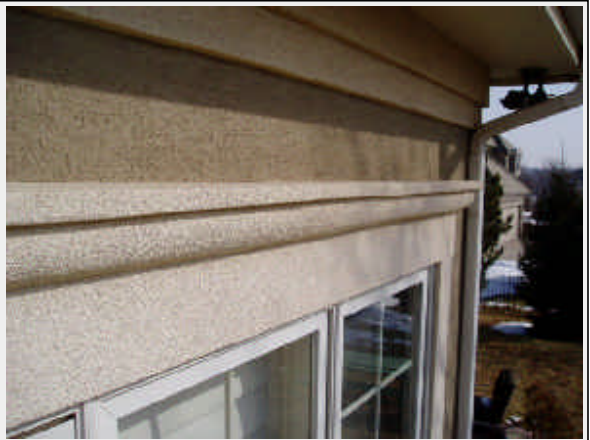
Raised banding noted around windows. Windows on first floor have banding above the windows that has a flat top surface. This is not allowed due to water sitting on the surface that is detrimental to the finish coating which will become soft. As noted in EIMA Guidelines 1996 Version, page 7.

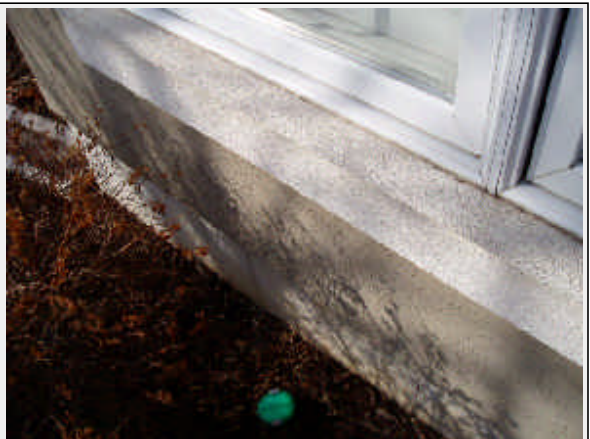
Window sills below all windows noted. Other than windows #1 thru #4, the installed sills should be tapered as noted above. Typical with or without a window pan is pictured in EIMA Guidelines, 1999 Version, page 14.

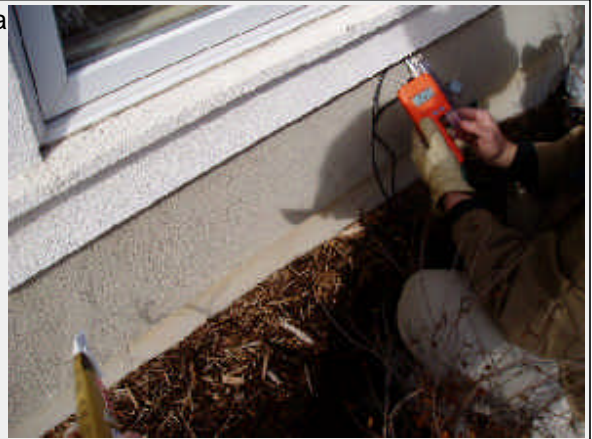
Below window W#16 there is evidence of a repair due to a vertical crack. I am pointing to repair in the left side of photo.

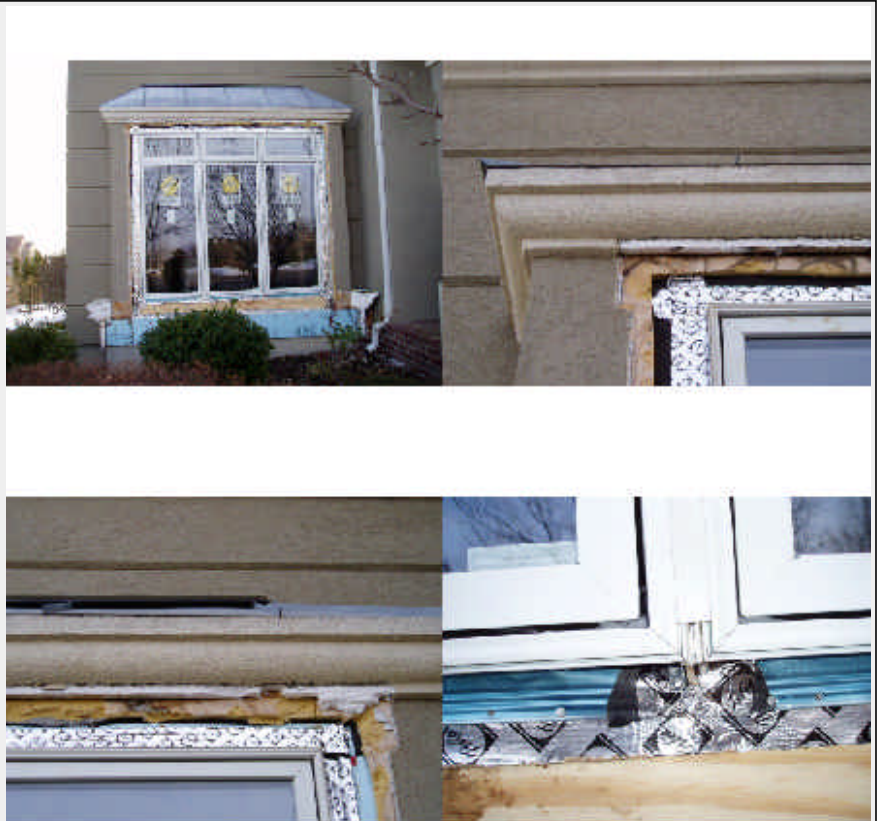
Repairs to Window #1 are in progress. Note water staining on the remaining foam which indicates prior water entry.

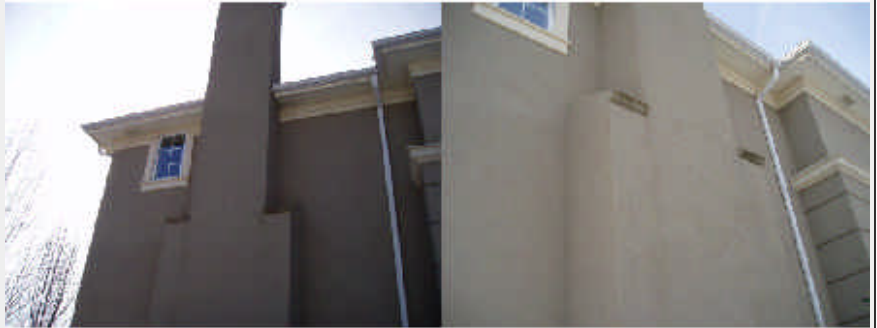
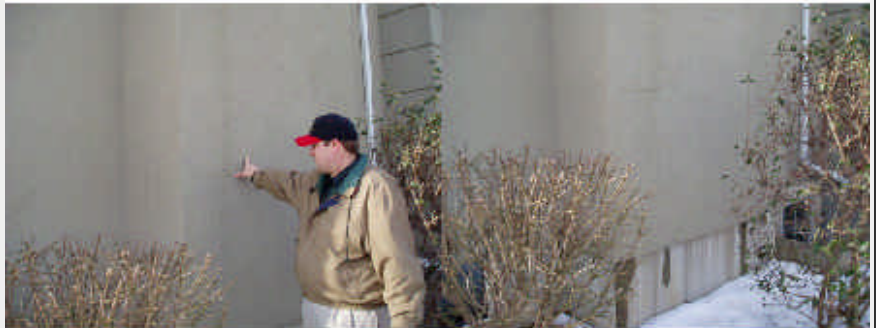
The fireplace is not flashed correctly as is evidenced by the water that is running down the stack from the roof edge to the concrete foundation below. Water was running out indicating that the stack substrate materials have been soaked and repair not only to the EIFS materials but the substrate will be needed after appropriate flashing is installed.

Note water visible on bottom of stack.

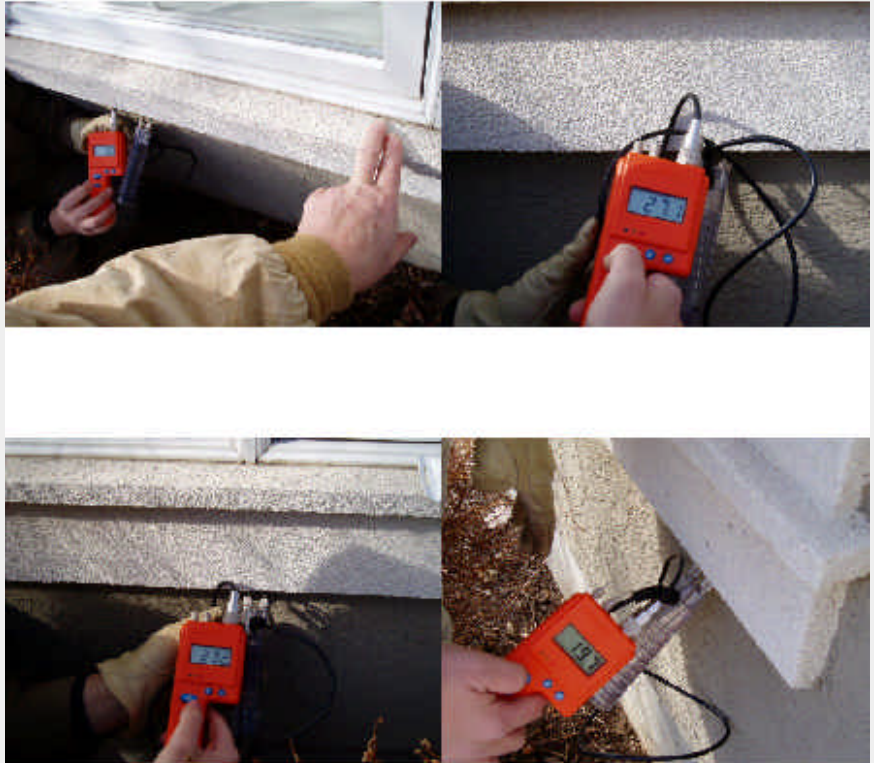
Photo #6:

Action Necessary - Higher than acceptable moisture readings were recorded. Readings in excess of 20% were noted. Excessive moisture readings were noted in the walls: Below windows, W#13, W#14, W#17. There are 2 other windows that have readings in excess of 18%, W#20, W#16. There are three other windows that were not tested The window that is being replaced. W#1, and W#2 and W#3 has foam so thick on the underside that moisture penetration pins are not long enough to penetrate to the substrate. The basement view under Window W#2 shows staining wood rot and mold growth. The area under Atrium door #3 was not accessible due to the concrete step but the under side from the basement shows rotted subfloor and mold. Photos of the Individual moisture readings are listed in Photo Log #6 thru end.

Stacked window W#13.

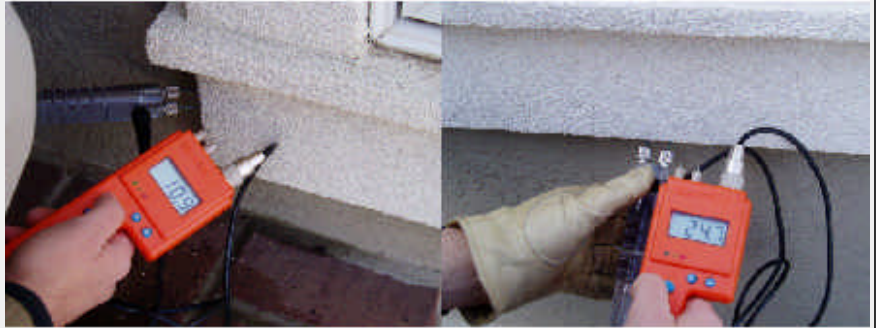
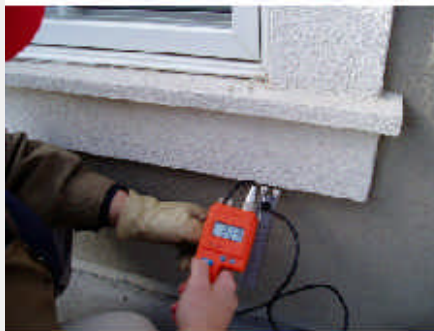
Photo #7:

Window W#14.

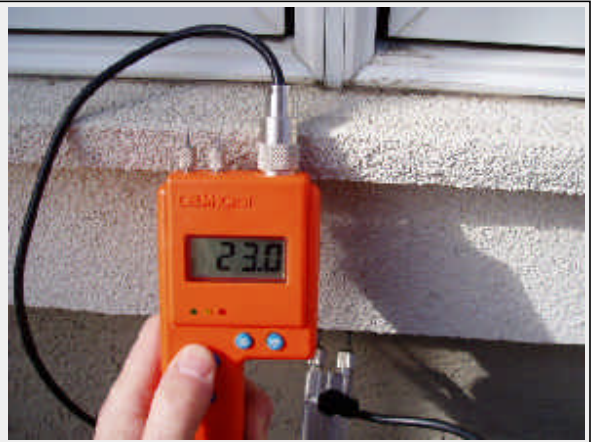
Photo #8:

Window W#15.

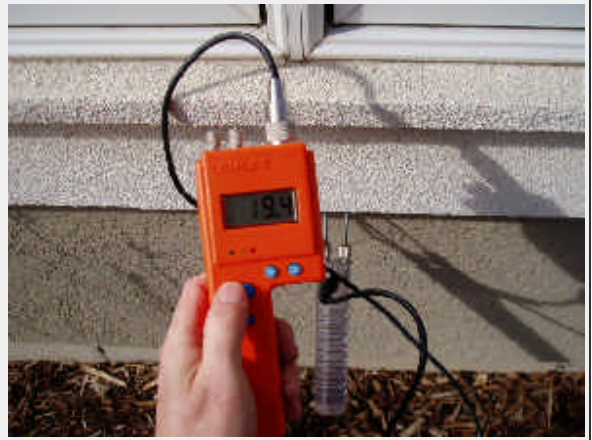
Photo #9:

Window W#16.

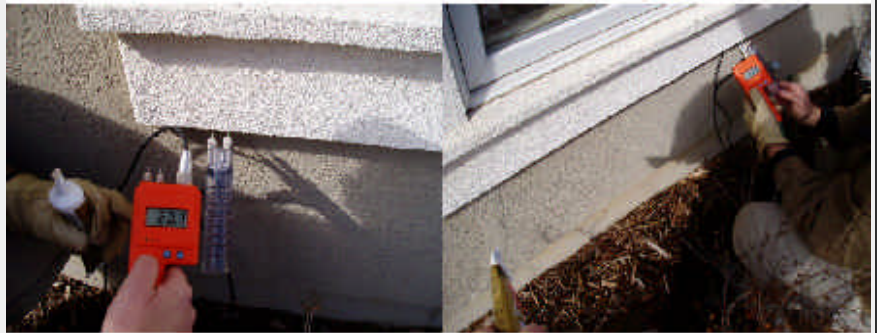
Photo #10:

Window W#17.
