COMMON AREAS, GROUNDS, SIDEWALK

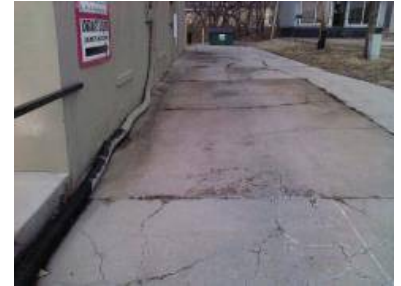
Site Drainage:

Immediate Action - There are areas of the lot that need adjustment to allow water to run off the property. There are areas that may allow water to interfere with the foundation.

The ground should slope away from the foundation and allow water to drain away rather than pond on the property. Ponding promotes insect infestation and makes grass difficult to maintain. Action Necessary.

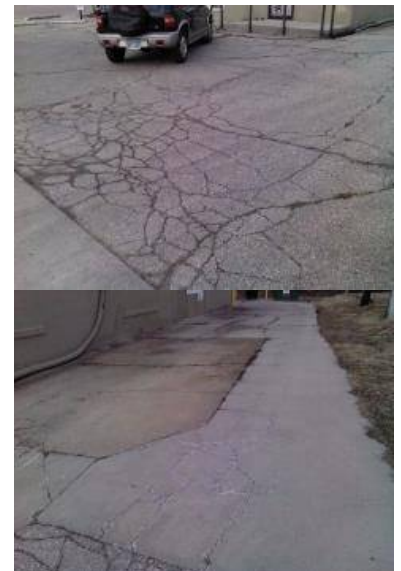
Parking Lot Condition:

Future Deferred - The parking lot while in useable condition will need either considerable repair or resurfacing. Asphalt or asphalt covered concrete base.

Immediate Action - The parking area for this structure needs immediate repair or resurfacing. Concrete parking area. Area along the North side needs replacement or mudjacking to eliminate water runoff issues.

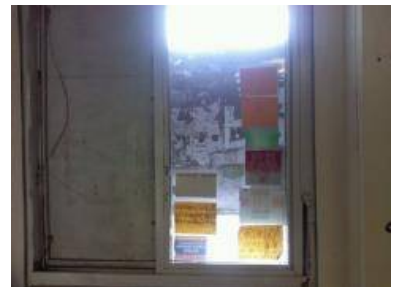
Windows:

Immediate Action - At least one window or associated hardware in the unit needs repair or replacement. No locking mechanism on window locks.

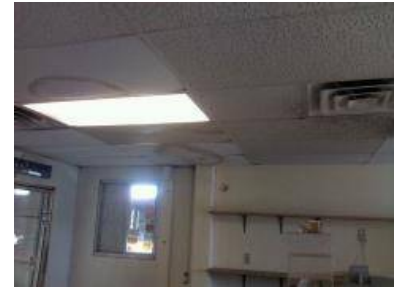
Immediate Action - The ceilings in the unit needs immediate repair. Evidence of prior leakage.

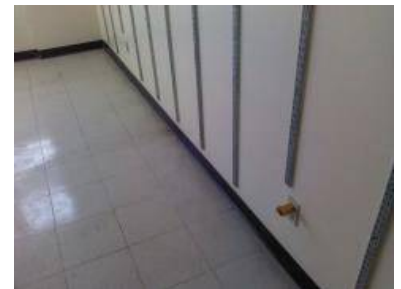
Electrical Outlets:

Action Necessary - At least one receptacle tested in this room is incorrectly wired or needs to be replaced. The receptacle is located on the South wall.

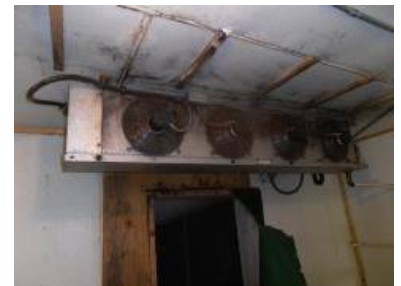
Cooler:

There is a cooler installed in the mid section of the area. with a 4 sectional cooling unit. The cooling unit did not put out adequate air temperature. Repair needed by a licensed HVAC Technician.

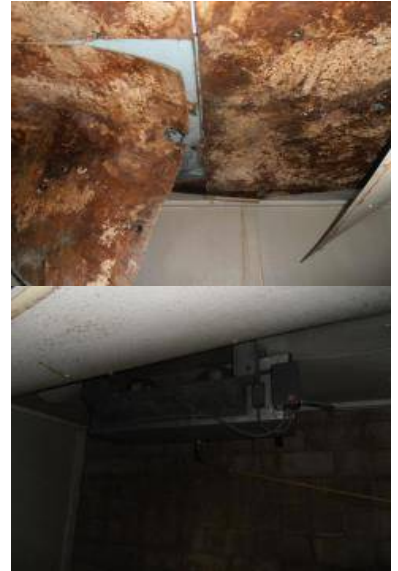
Immediate Action Required - There is a rear cooler room that is in poor condition. The ceiling has fallen as a result of moisture from within. Have a contractor determine needed repairs and costs.
Also the insulation of the rear wall of the cooler is not installed.

Action Necessary - The installed cooling equipment is not functional. Repair or replacement needed.

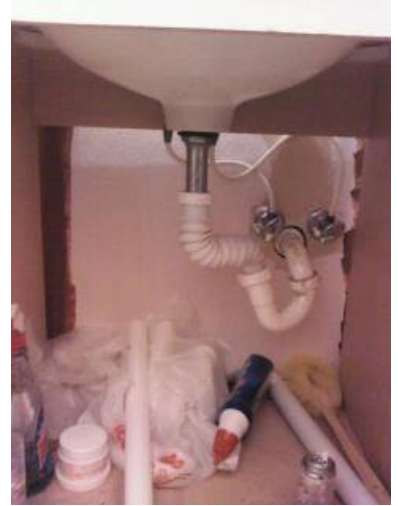
Basin and Drain Fixture:

Immediate Action - There is no approved P Trap installed, or it is installed in an unacceptable manner. Services of a Qualified Licensed Plumber are recommended.

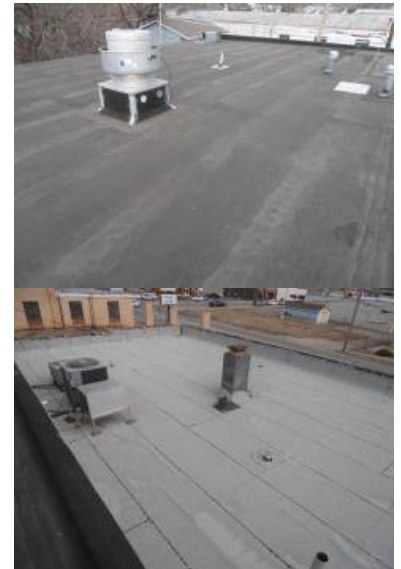
Roof Covering Material Condition:

Upper level roofing materials are older and likely to need replacement within 4 years.

Lower level roofing materials appear to be newer but likely replacement within 4-6 years due to creases in the covering materials.

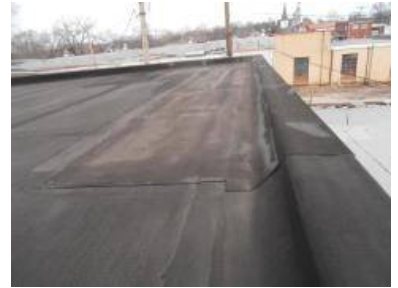
The upper roof materials show evidence of potential leakage. There are several areas that have repairs made. There is an open seam along the East parapet wall has an open seam that needs to be repaired.

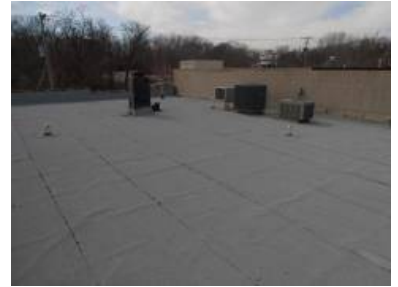
The lower roofing materials show evidence of creases which will likely fail over the next few years.

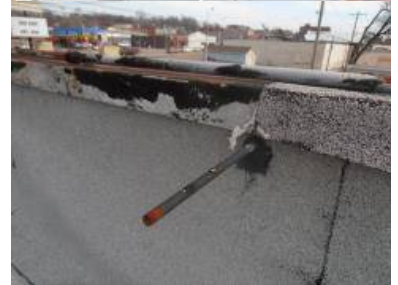
Action Necessary - There are two holes in the parapet where the Liquor Store sign has penetrated. These need to be sealed.

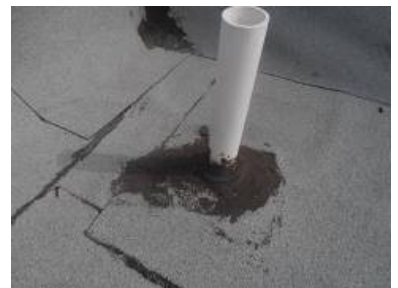
Flashing:

Action Necessary - There are at least two plumbing penetrations through the roof line that need to be sealed.

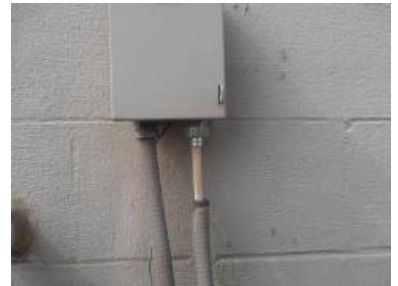
Service Disconnect:

Action necessary - The whip has pulled loose from the service disconnect. This condition will allow water to enter the conduit. Repair needed.

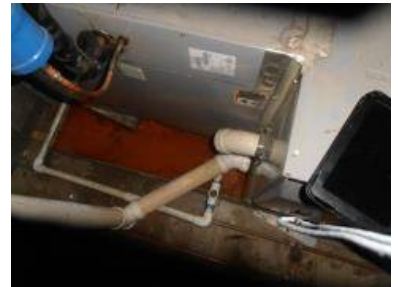
Condensate Line:

Immediate Action - There either is no condensate drain line, or it is installed in such a manner that it will not adequately eliminate the collected condensate. Action is needed to prevent deterioration caused by moisture. Condensate pan and secondary pan is near full and the secondary drain is not functional. Services of a licensed HVAC Technician is needed to make repairs. Secondary pan located in attic under furnace.

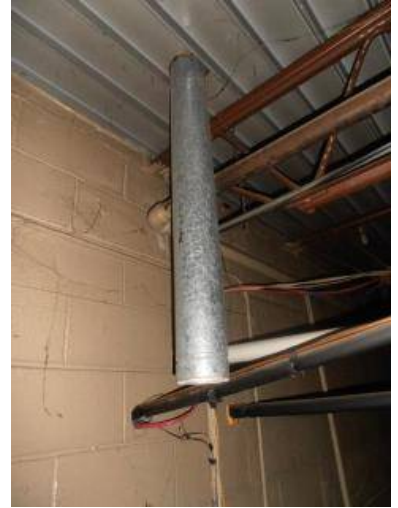
There is an abandoned flue pipe installed through the roof line. This flue pipe is allowing air into the attic and for combustion. The flue pipe should be adjusted to prevent moisture intrusion.

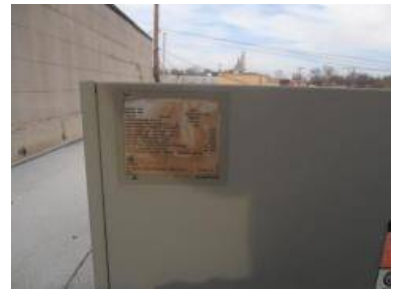
Older unit information plate fade to degree that it is unreadable.

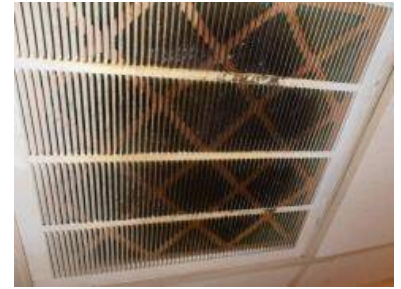
Filter Condition:

Immediate Action - Replacement is recommended. The filter is not functioning as intended. The filter is in a condition that may cause damage to the heat exchanger due to restricted airflow across the heat exchanger. Soaked with grease.

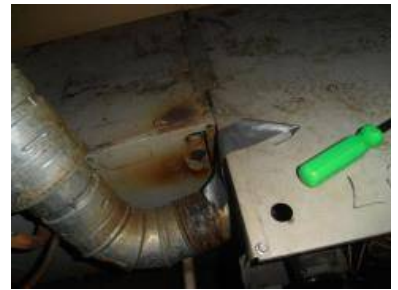
Flue Condition:

Immediate Action - The furnace/boiler flue as installed needs immediate action. An unsafe condition exists. Possible health hazard. Possible blockage in the flue.

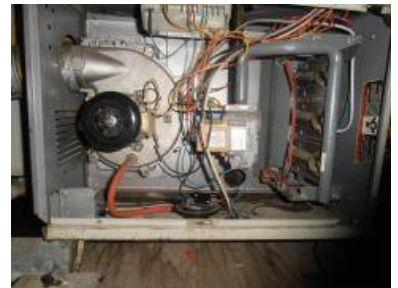
Action Necessary - The exterior of the furnace cabinet cover will not stay in place. Services of a licensed HVAC Technician is needed.

No. End shot burners block access to the heat exchanger.

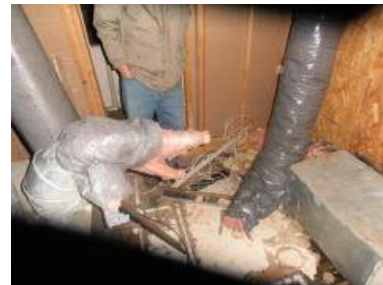
The apartment does not have its own heat source. There is one duct from the restaurant furnace that goes to the "Bedroom" on the second floor. It is disconnected in the furnace room.

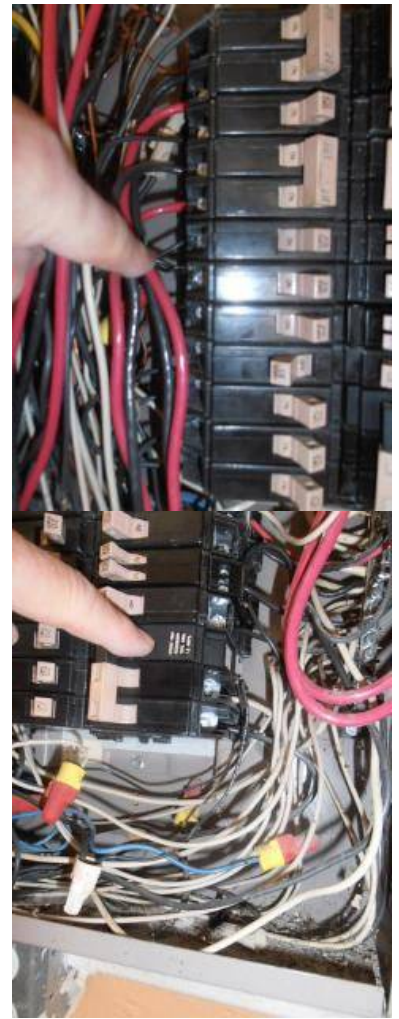
Condition of Wiring in Panel:

Action Necessary - Electrical circuitry wiring in the downstream power panel shows some condition that calls for immediate action of a qualified licensed electrician. There are two wires to a breaker or fuse. These need to be separated, each having its own breaker or fuse. Sixth breaker up on the left side.

Action Necessary - Electrical circuitry wiring in the downstream power panel shows some condition that calls for immediate action of a qualified licensed electrician. There is a pair of undersized wires noted breaker third up on right side.

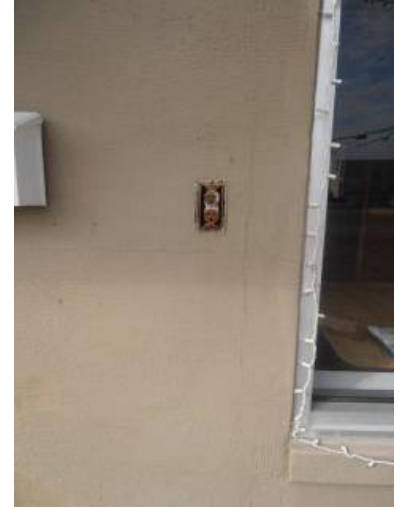
Exterior- Outlets/ Switches:

Action Necessary - There is at least one outlet on the exterior that is not functional and is missing the required weather protection. Services of a licensed electrician is needed.

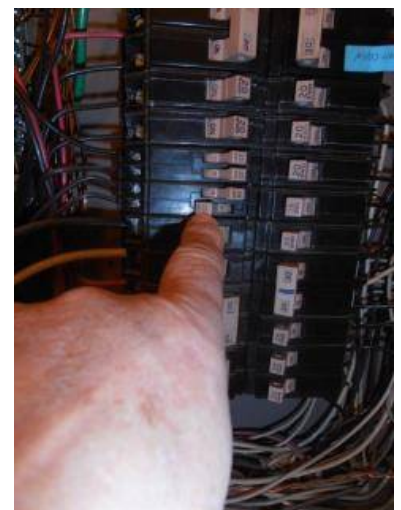
Action Necessary - Breakers in slots 6 & 7 have breakers that are shorted out. Services of a licensed electrician are needed to determine cause of the shorts and make repairs.
