BUILDING STRUCTURAL INSPECTION

Sales and Manufacturing.

2 structures. Building #1 is the showroom, parts room and repair shop. Building #2 is a Pole Barn behind and to the West of the main structure.

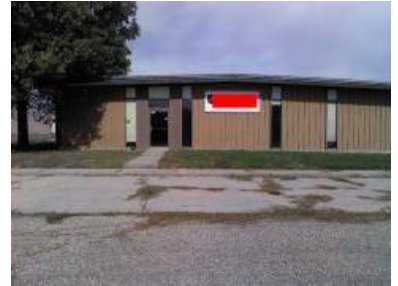
Front View #1

Building #1 faces South.

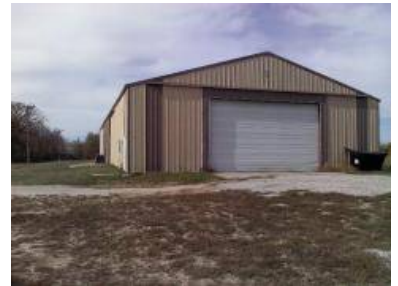
Front View #2

Building #2 faces East.

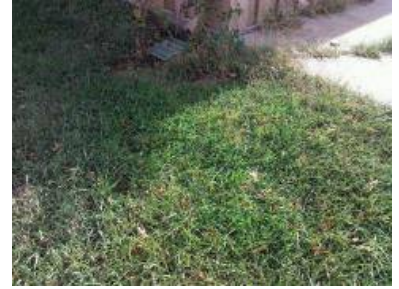
Immediate Action - The drainage around the foundation needs immediate adjustment in order to divert the water runoff away from the foundation. Ground slope should be adjusted to a rate of at least 1/2 inch per foot for 6 feet away from the foundation. Noted at Northwest corner.

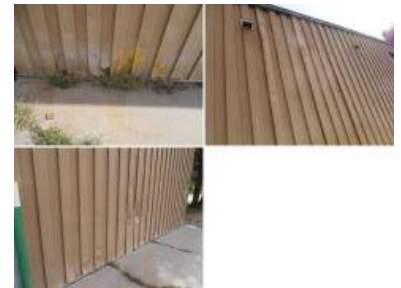
Action Necessary - There is considerable damage noted to the West side of building #1 Metal siding.

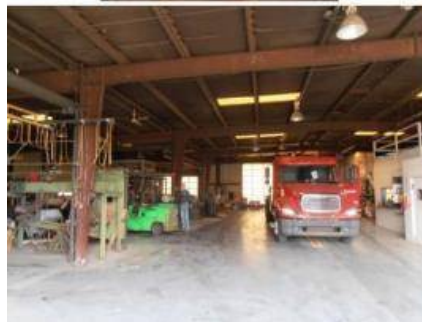
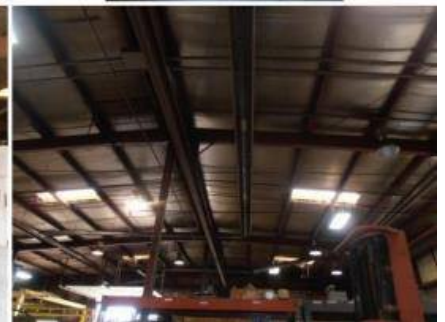
Structural steel appears to be in satisfactory condition for both walls and ceiling.

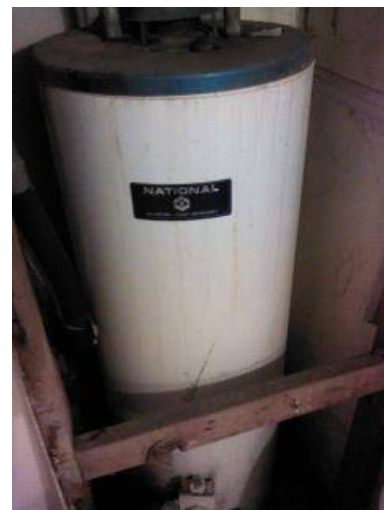
Men's Bathroom West wall.

National Brand - 42 years. Function doubted. I have never seen one older than 27 years and functional. Typical life span is 15 years.

There is rust noted from the underside of the tank as seen from the firebox.

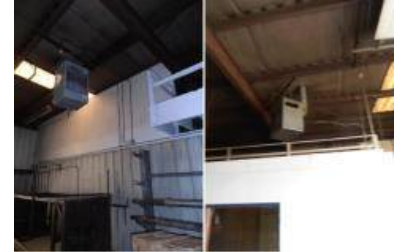
Action Necessary - There are two hanging furnaces in the shop area. Neither activated using normal controls.

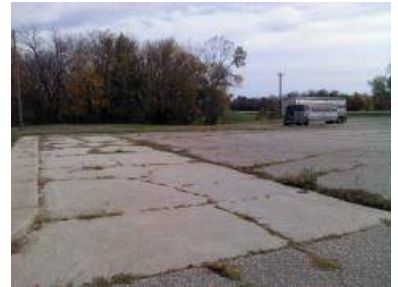
Future Deferred - The parking lot although in useable condition will need either considerable repair or resurfacing. A seal coat will be needed over the top of the existing material.

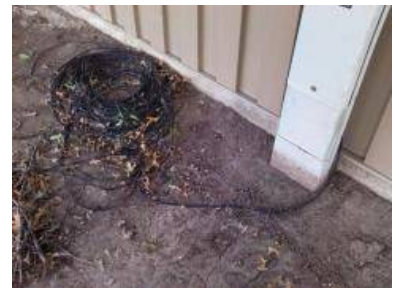
Action Necessary - The service is not connected to the service pole. Overhead - The overhead telephone lines are secure at the pole and are piled at the structure.

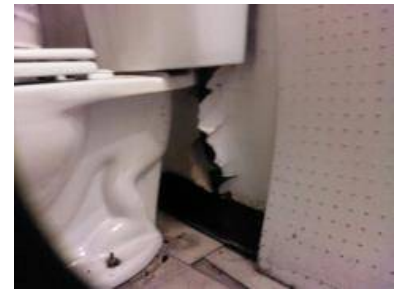
Immediate Action - There are some cracks or deterioration in the walls in the restroom that need repair. Due to water damage.

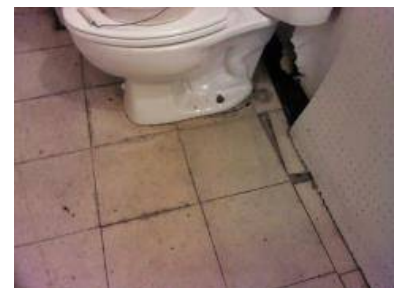
Immediate Action - The ceiling in this restroom needs immediate repair.

Immediate Action - The flooring in this restroom is in need of repair. Due to water damage.

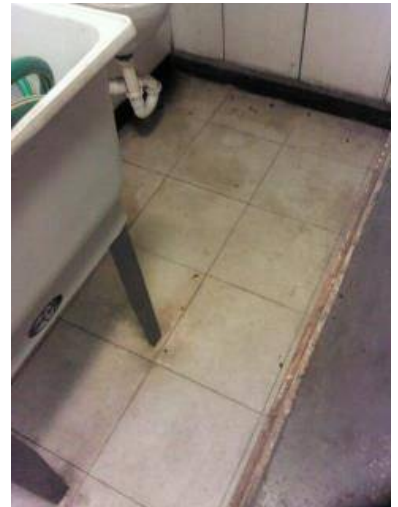
Immediate Action - The flooring in this restroom is in need of repair. Water damage.

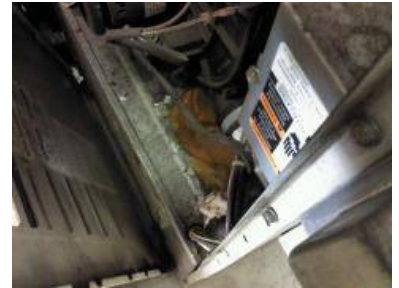
Immediate Action - Conditions exist in the exterior of the cabinet resulting in deterioration or holes which may require repair or replacement. Rust noted on interior of cabinet, due to exhaust condensate.

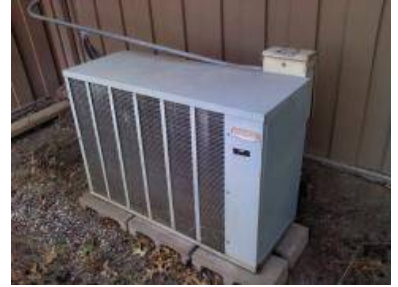
1 This unit mfg. 1989. If working, plan for replacement soon. Typical lifespan is 15 years.

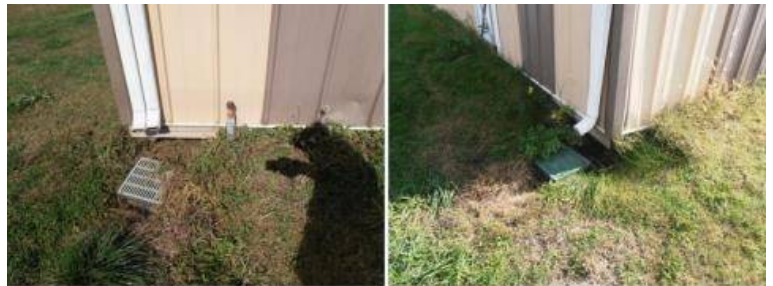
The gutter system on the roof edge appears to be functional and adequately sloped to carry the water to the downspouts. Action Necessary - The downspouts appear to be in need of repair or replacement in order to function properly. Action Necessary - The splash blocks as installed appear to be in need of repair or replacement. At least one of the splash blocks are missing. There is serious soil erosion that needs to be addressed. Water also gets into the structure due to the lack of runoff of roof water.

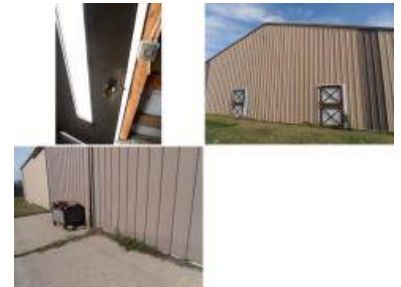
Action Necessary - The slider door is not functional.

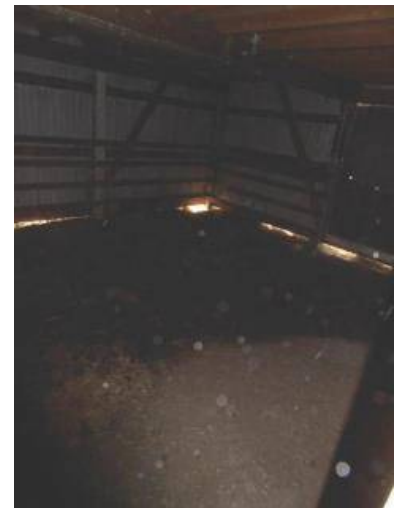
Satisfactory - The warehouse floor is in satisfactory condition. Thickness of the floor is undetermined. For intended usage of anything other than as previously used you will need the services of an engineer to determine the proposed load and an analysis of the existing floor bearing capability. There are several different pours and am unable to determine thickness of individual pours.

There is one room on the Southwest corner that does not have a poured floor.

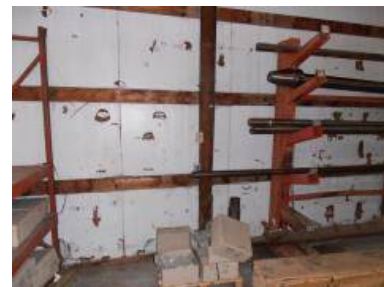
Yes - The wall insulation in the front half is vinyl covered polyisocyanurate. There are numerous holes torn through the insulation.

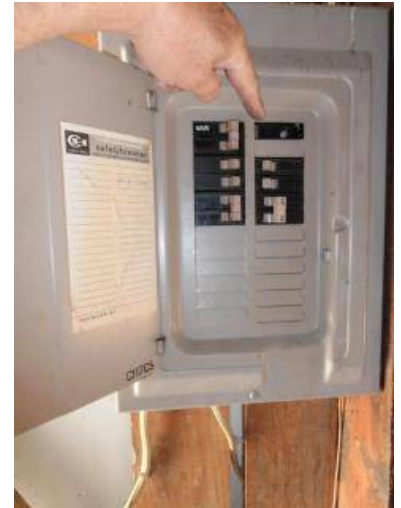
Immediate Action - The power panel as a container for safely covering circuitry and components requires immediate action to minimize possibility of electrical shock. There are open slots in the panel breaker cover where a breaker is missing.
