# HOME CONDITION REPORT

12345 Anywhere St. Anytown, US

Inspected By: Charles E. Sanderson  
American Residential Inspections, Inc.  
P. O. Box 186 Lansing, Kansas 66043  
913-680-1757 Fax: 913-680-1758

Inspection Date: 01/10/2004

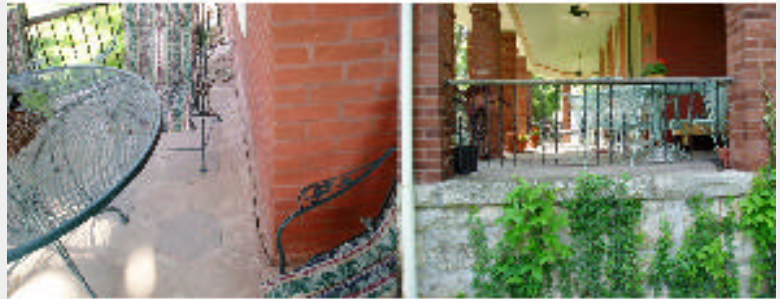
**Entry way Stoop:**

**Action Necessary** - The entry porch needs repair or replacement due to deterioration or settlement. The settling porch has moved to the point that major repair, or mud jacking is needed to prevent water from collecting and settling the soil under the porch further. Estimates from qualified professionals are called for.

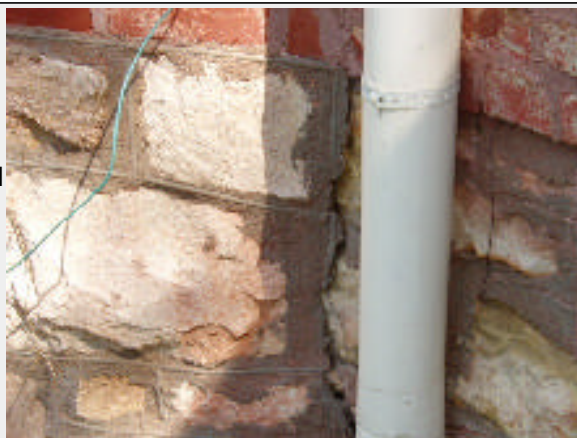
Yes - Cracking in the vertical foundation walls was noted from the exterior. All cracks in the foundation walls need to be sealed with mortar to prevent the entry of water and deterioration.

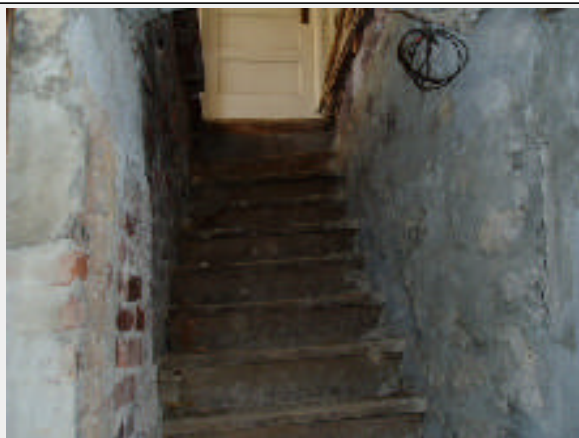
**Attention Needed** - There is no handrail present for this staircase and the steps are not level creating a potential trip hazard.

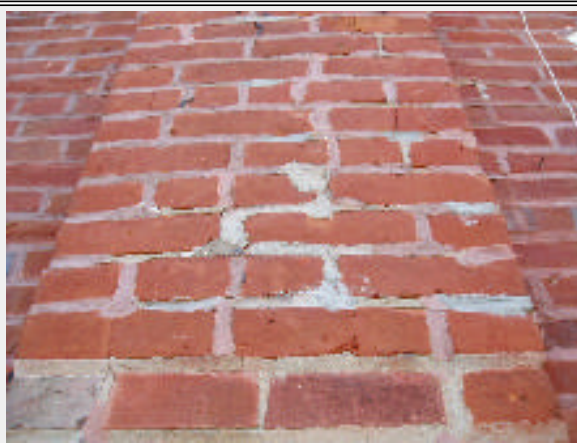
**Attention Needed** - The exterior siding material or finish is in a condition that requires minor repair to prevent further deterioration.

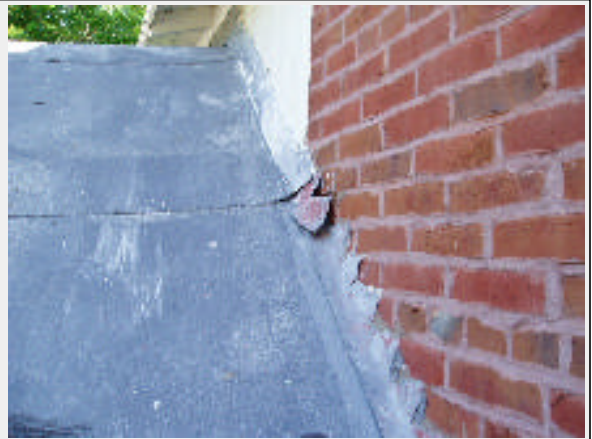
**Attention Needed** - Some portion of the roof flashing needs to have some repair. Flashing above exterior stair case to second story needs attention.

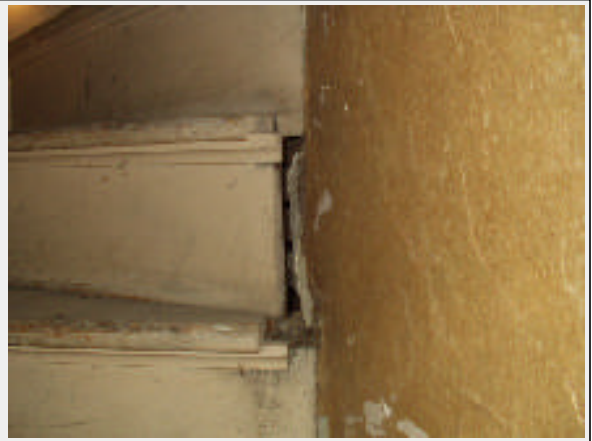
**Attention Needed** - There is a full staircase installed. Step needs to be secured, and repaired.

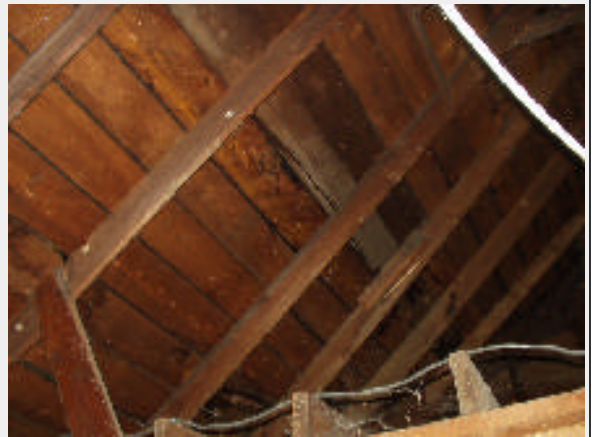
Butted one inch nominal boards. There was evidence of prior leaks on decking material.

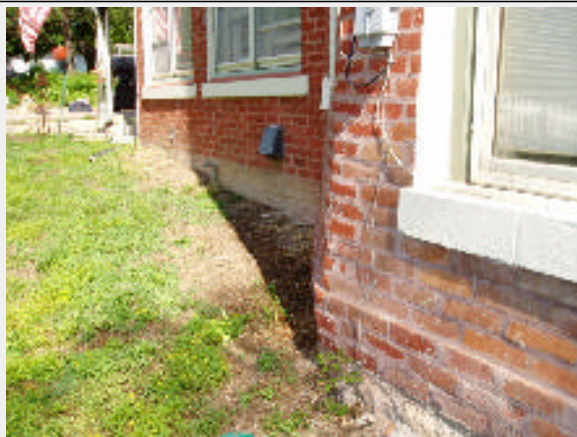
**Attention Needed** - The exterior siding material or finish is in a condition that requires minor repair to prevent further deterioration. There is a bulge and a repaired area under the main level bay windows on the South side that is the result of foundation and floor settlement. Monitor for further movement and take action as needed.

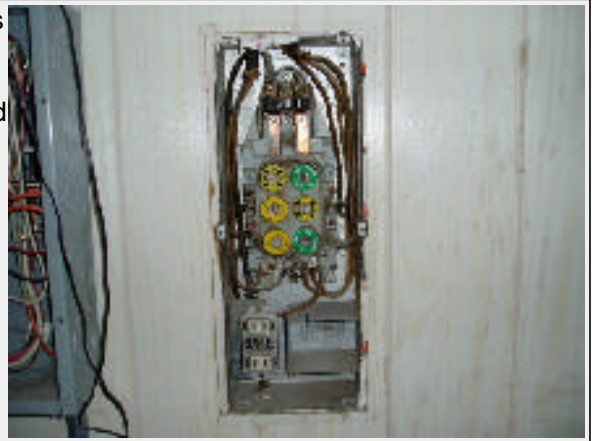
There is a third panel that has 6 - 30 amp screw in fuses. These are over fused and the result is a potential fire hazard and need to be replaced with appropriate 20 amp fuses..

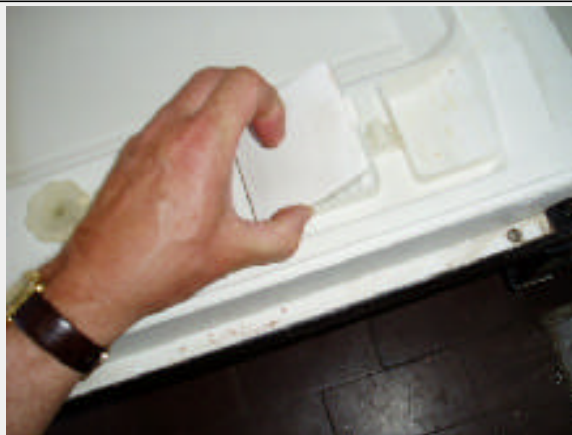
**Attention Needed** - Through a visual or functional test, it was determined that the dishwasher needs some repair work.

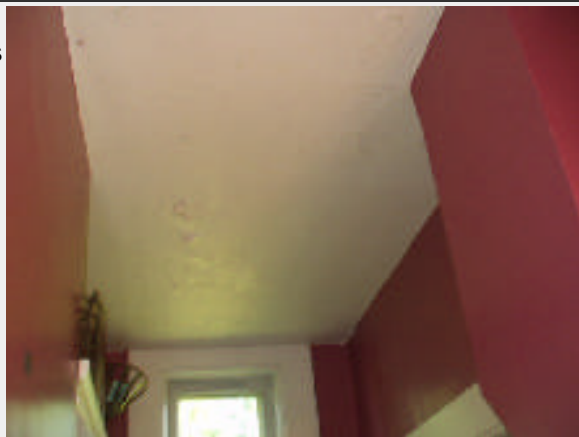
**Attention Needed** - The ceiling in this bathroom needs some repair. Cracking noted.

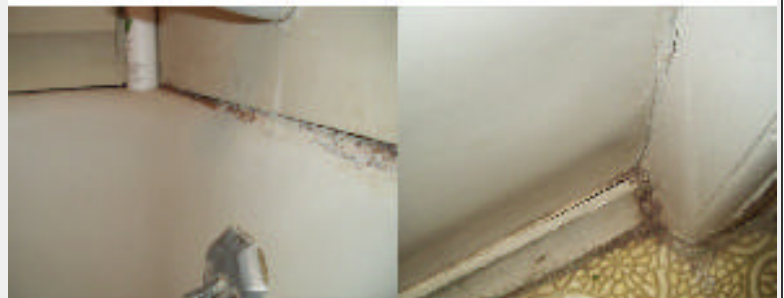
**Caulking / Water Contract Areas:**

**Attention Needed** - The caulking in the water contact areas appears to need attention. Damage may result if not corrected. The seam where the tub or the shower meets the flooring needs to be caulked to prevent damage. The wall - tub or shower seam needs to be caulked to prevent moisture from entering the wallboard.

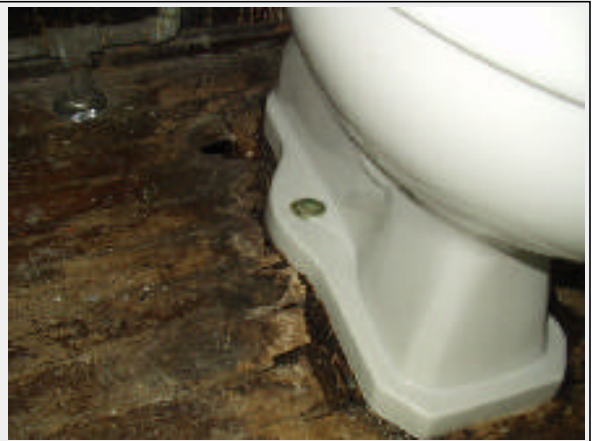
**Action Necessary** - The flooring in this bathroom needs repair. The cause apparently is from water. Action is necessary to make necessary repairs. The floor is hardwood.

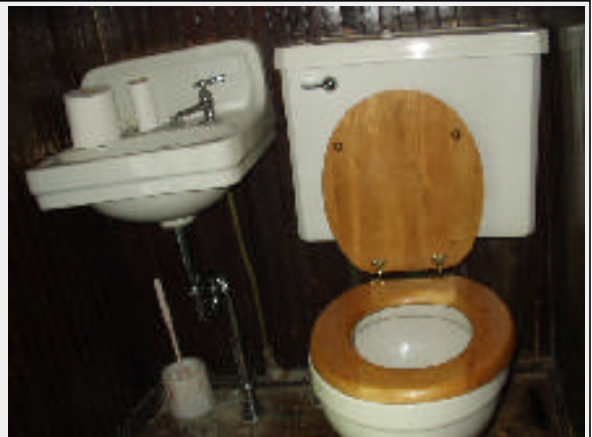
Satisfactory - The toilet in the master bathroom appears to be functional, it was noted that the tank is not installed level. **Action Necessary** - The toilet in the master bathroom needs repair.

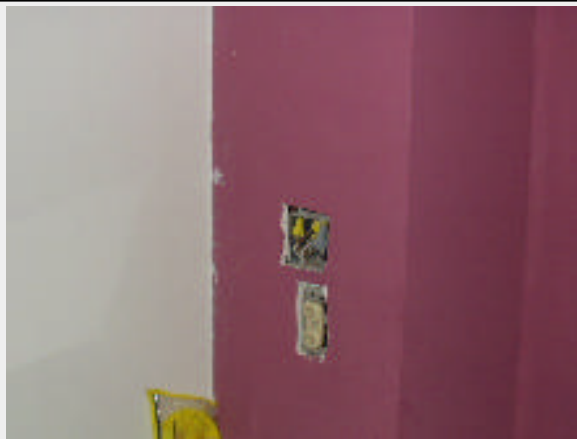
Attention Needed - The switch covers need to be replaced.

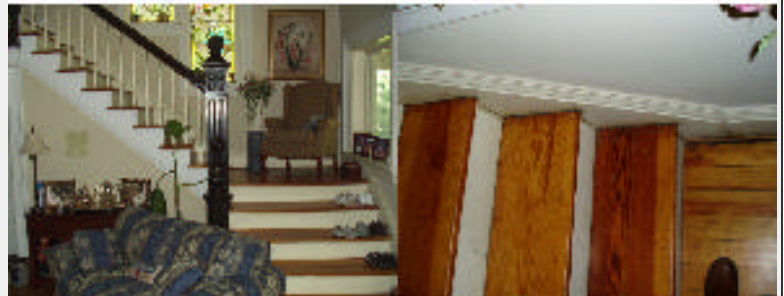
**Main Staircase:**

Satisfactory - The main staircase is appropriately installed. The staircase has a landing. There was separation noted between the staircase and wall at the landing level.

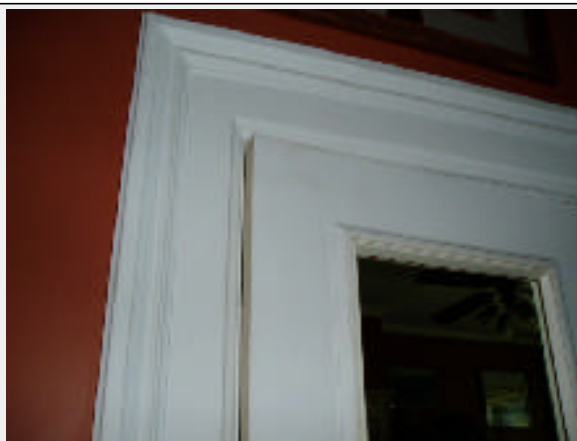
**Attention Needed** - The closet door or fixtures need some adjustment or repair. Doors do not close due to Settlement.

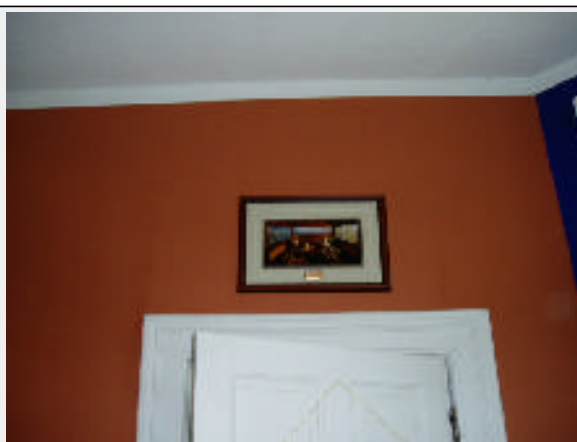
There is some minor cracking in the plaster. Most likely this is due to slight settlement in the bay area.

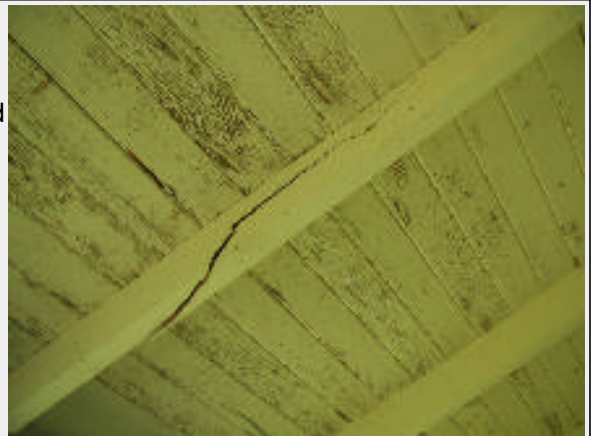
**Action Necessary** - There is a condition in the ceiling of this room that needs to be repaired. Rafter is broken and needs a new one sistered-in next to it.

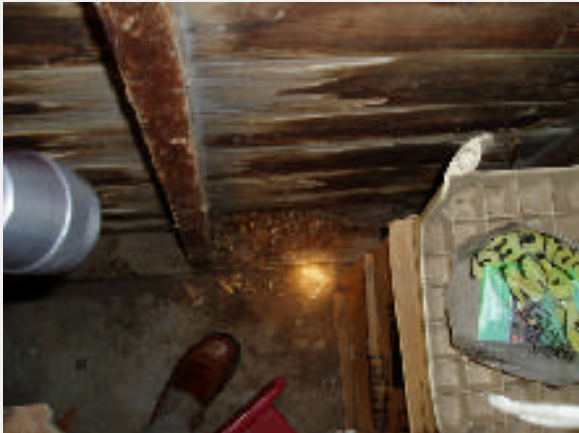
Attention Needed - There is some portion of the framing that needs some minor repair for it to perform satisfactorily. Termite damage to sill on the North and West walls. Visibility limited due to items being stored.
