EXTERIOR INSULATION & FINISH SYSTEMS

PRELIMINARY INFORMATION

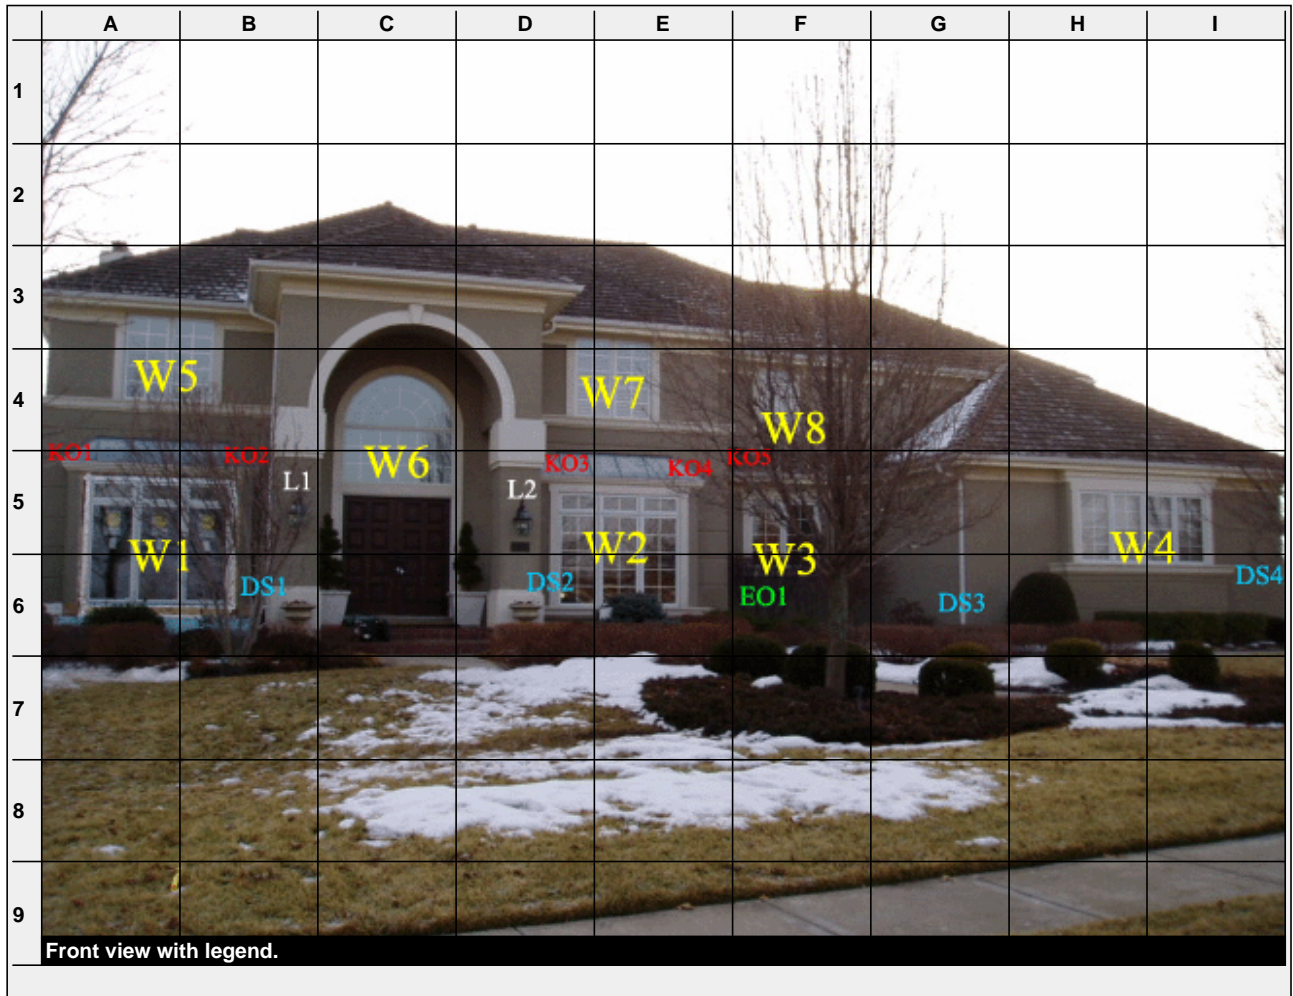
Photo #1:

Yes. Below window W3, Rear Door Atrium 3, and currently repairs underway under window W1. Water staining of the subfloor & wood framing noted. White growth noted in both locations.

Photo1,2,3=W3, Photo 4 Atrium Door.
