COMMON AREAS, GROUNDS, SIDEWALK

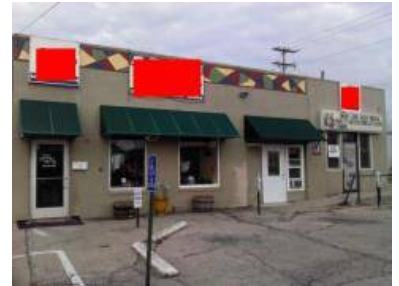
Structure Front View

The front of the structure faces East.

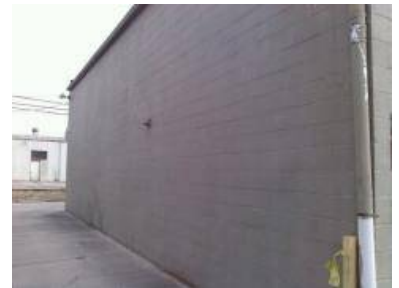
Structure Rear View

The rear of the structure faces West.

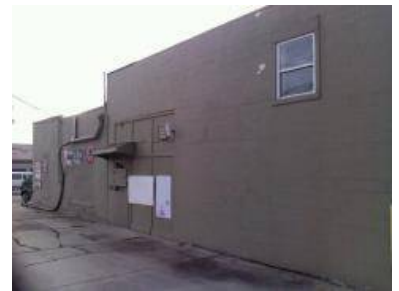
Structure Right Side View

The right side of the structure faces North.

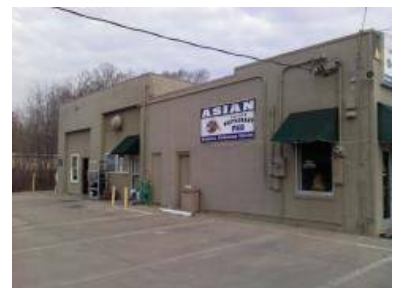
Structure Left Side View

The left side of the structure faces South.

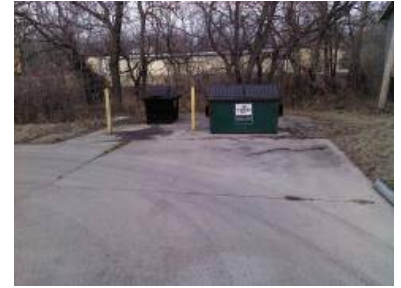
Dumpster Area:

There is a separate area designed with a trash bin and grease bin installed in a clearly marked or fenced area. It is located away from the structures. Northwest corner.

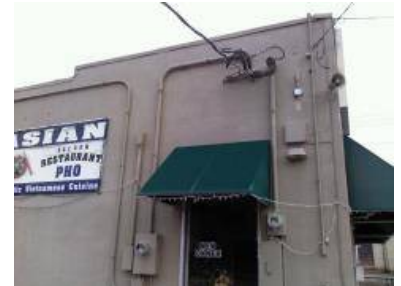
Electric Service:

Overhead.

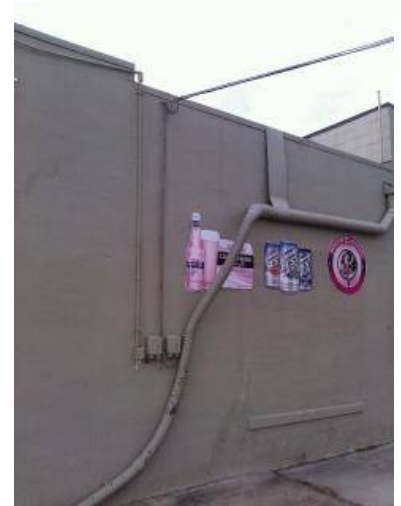
Telephone Service:

Overhead - The overhead telephone lines are secure at pole and at the structure.

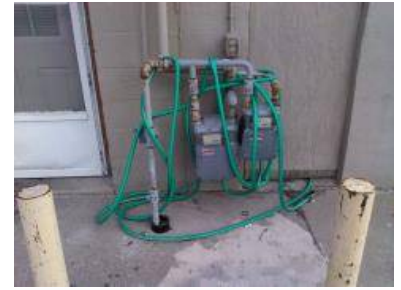
Fuel Source:

Natural Gas. Provided by a regulated service company or utility.

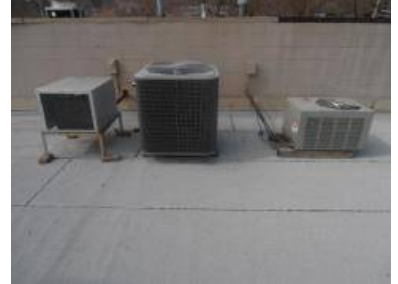
Unit/Condenser Location:

The condenser cabinet is located on the roof. Center unit.

Action necessary - The whip has pulled loose from the service disconnect. This condition will allow water to enter the conduit. Repair needed.

Immediate Action - There either is no condensate drain line, or it is installed in such a manner that it will not adequately eliminate the collected condensate. Action is needed to prevent deterioration caused by moisture. Condensate pan and secondary pan is near full and the secondary drain is not functional. Services of a licensed HVAC Technician is needed to make repairs. Secondary pan located in attic under furnace.

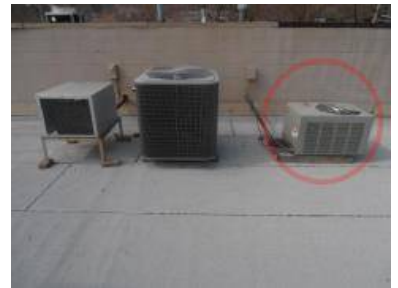
Unit/Condenser Location:

The condenser cabinet is located on the roof. North unit.

Immediate Action - There either is no condensate drain line, or it is installed in such a manner that it will not adequately eliminate the collected condensate. Action is needed to prevent deterioration caused by moisture. Condensate pan and secondary pan is near full and the secondary drain is not functional. Services of a licensed HVAC Technician is needed to make repairs. Secondary pan located in attic under furnace.

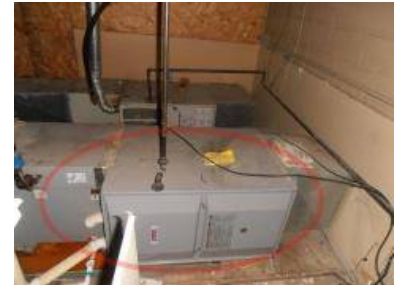
Heating System Location:

Attic South unit for Restaurant.

Immediate Action - Replacement is recommended. The filter is not functioning as intended. The filter is in a condition that may cause damage to the heat exchanger due to restricted airflow across the heat exchanger. Soaked with grease.

Immediate Action - There is a condition existing that requires immediate repair so the ducts can properly deliver required airflow. The flex duct leading to the apartment bedroom is torn loose. Removal and closure needed.

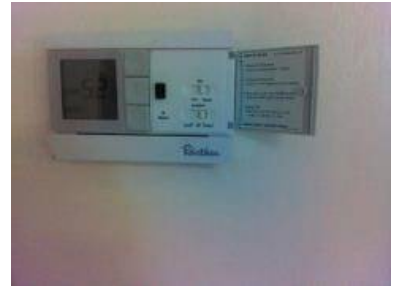
No - The heating unit was not tested the thermostat did not respond using the thermostat controls.

Action Necessary - The exterior of the furnace cabinet cover will not stay in place. Services of a licensed HVAC Technician is needed.

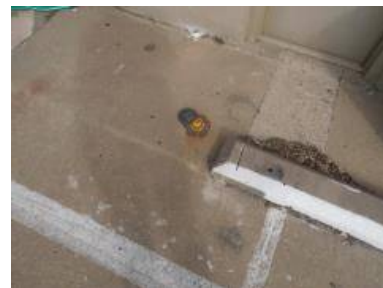
Location of Waste Line Cleanouts:

Outside the South wall at the side entry door to the Restaurant kitchen.

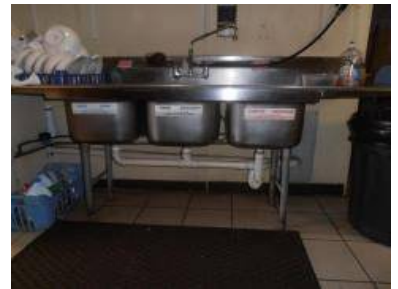
Sink and Drain Lines:

Stainless Steel counter with molded in sinks. Satisfactory - The sink and drainage lines appear to be satisfactory. Triple sink Sanitize, Wash, Rinse.

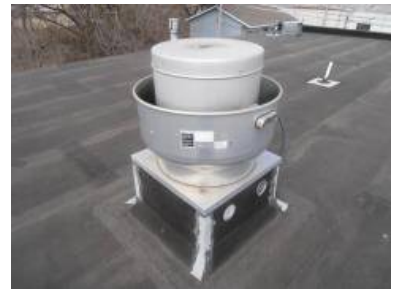
Range Hood:

Satisfactory - The commercial range exhaust hood and exhaust fan appeared to work correctly. The exhaust hood is directly vented to the exterior of the structure.

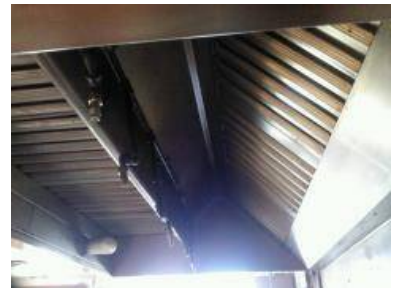
Range Hood Fire Extinguisher System:

The system was not tested. The local municipality requires periodic testing by a professional service.

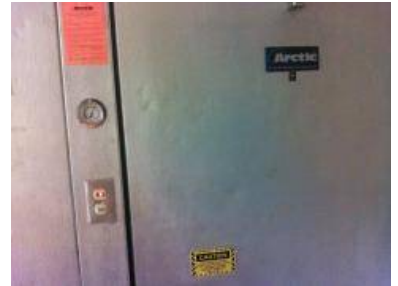
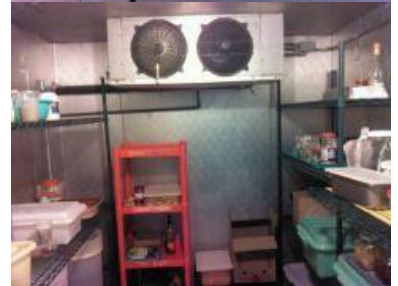
Refrigerator:

Type Unit present. Walk in type unit is installed. Temperature in the refrigerator at time of inspection:36 degrees.
