# HOME CONDITION REPORT

12345 Anywhere St. Anytown, US

Inspected By: Charles E. Sanderson  
American Residential Inspections, Inc.  
P. O. Box 186 Lansing, Kansas 66043  
913-680-1757 Fax: 913-680-1758

Inspection Date: 01/10/2004

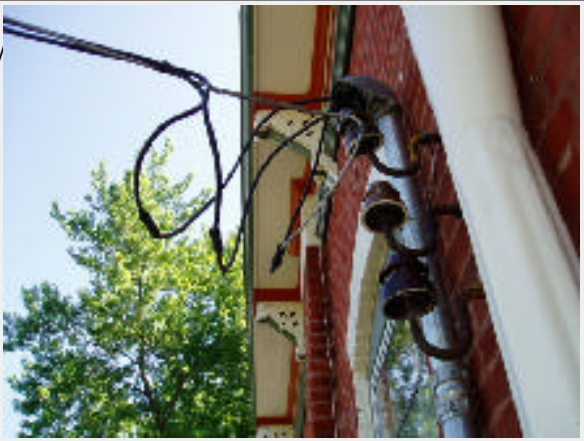
Service Voltage:

The incoming electrical service to this structure is 120/240 volts.

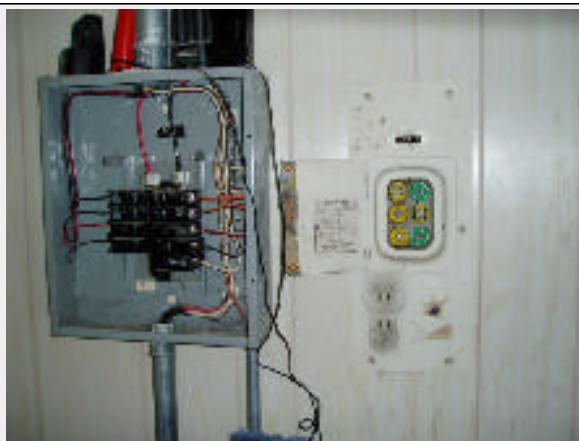
**Downstream Power  
Distribution Panel  
Location:**

Laundry room, second floor.

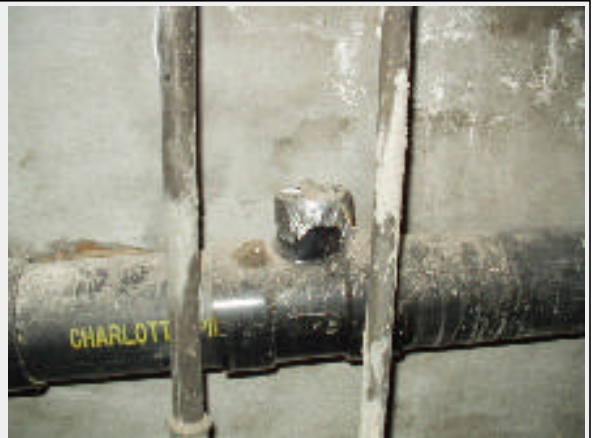
**Location of Leak in  
Waste Line:**

Basement, waste pipe going through South wall, above main water cutoff valve.

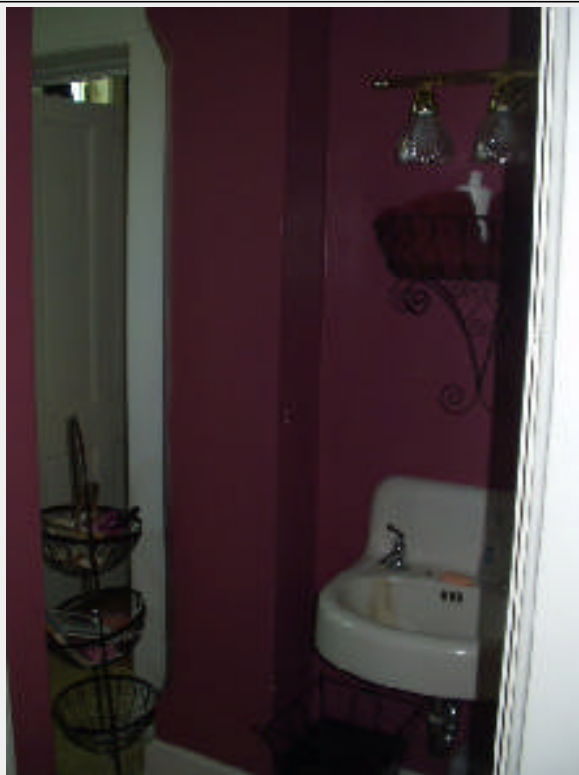
### Location:

between Master Bedroom  
and Den.

**Attention Needed** - The entry door or hardware to this bathroom needs some adjustment or repair to function appropriately. Settlement noted.

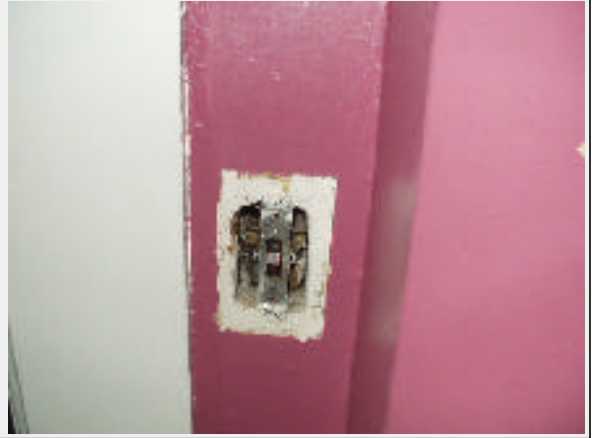
**Light Switch:**

Satisfactory - The light switch is satisfactory, although no switch plate cover in place.

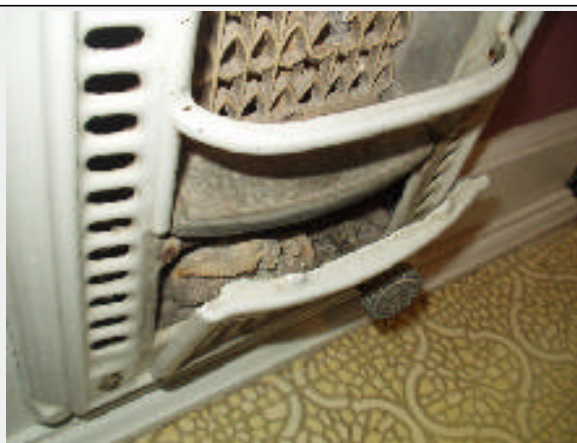
**Heat Source:**

Gas Fired Heat Source - There is a gas-fired heat source located in this bathroom, not tested for functionality. The inspector noted a towel located inside the heater. Do not use without having function checked by a professional HVAC Technician or Gas Company.

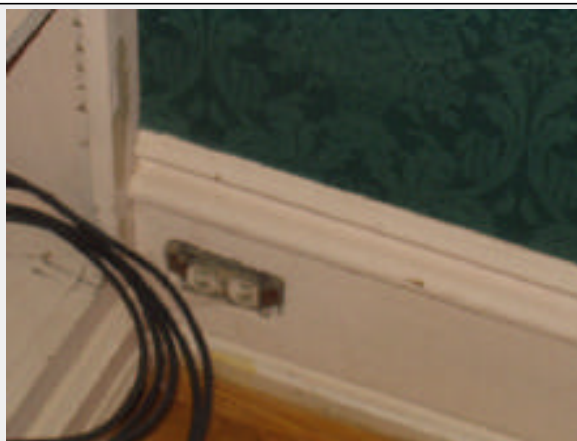
**Electrical Outlets:**

Satisfactory - 2-prong ungrounded outlets.  
**Attention Needed** - At least one outlet noted needs a new outlet cover.

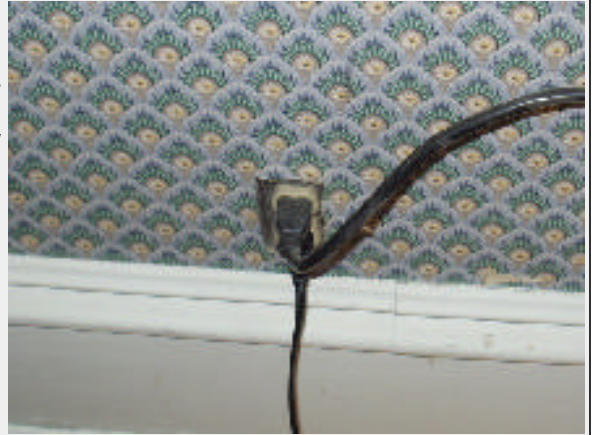
**Electrical Outlets:**

Satisfactory - The outlets tested in this bedroom are correctly wired and grounded.  
**Attention Needed** - At least one outlet noted needs a new outlet cover.
